Cold Spray for Repair of Magnesium Gearboxes

ARL Center for Cold Spray

8 February 2011

Demonstrate and qualify cold spray aluminum alloy coatings which provide surface protection and a repair/rebuild methodology for Mg alloy components on Army and Navy helicopters and advanced fixed-wing aircraft such as the Joint Strike Fighter

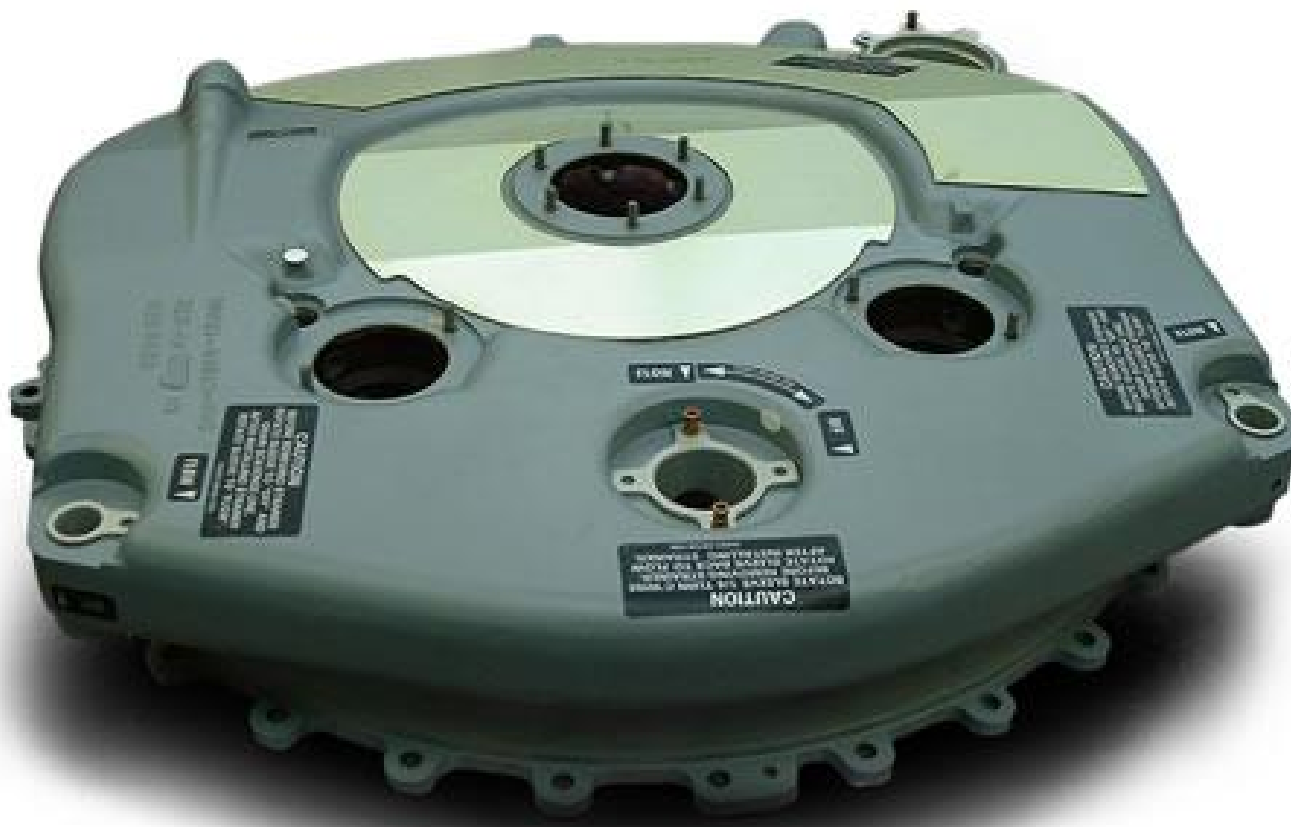
Sump Assembly Main Module-Main Gearbox Repair

*Substrates: ZE41A
& AZ91C
Magnesium
Coating Material:
CP-Aluminum
and/or 6061 Al*

*Total Replacement Cost Savings estimated to be **\$935,000.00/ year***
